## Corrosion Prevention Material Case History

### Marine and Hull Protection:

### 1988 Cobia Odyssey 265

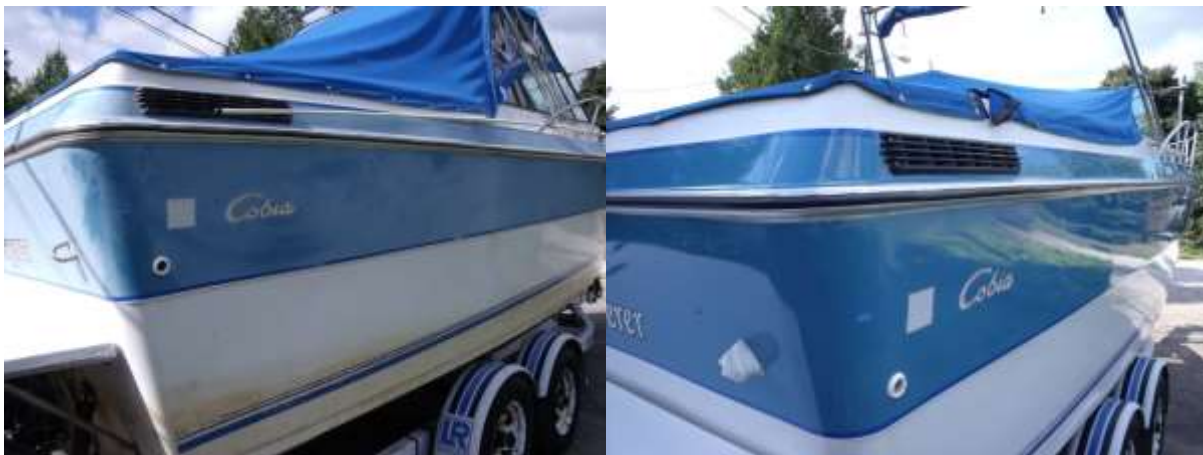
**APPLICATION:** The boat was pulled out of the water for winter storage and during the process of cleaning, the hull was completely power washed using a hull cleaner. The power washing and cleaning removed all remnants of algae, slime, wax, and polishing compounds.

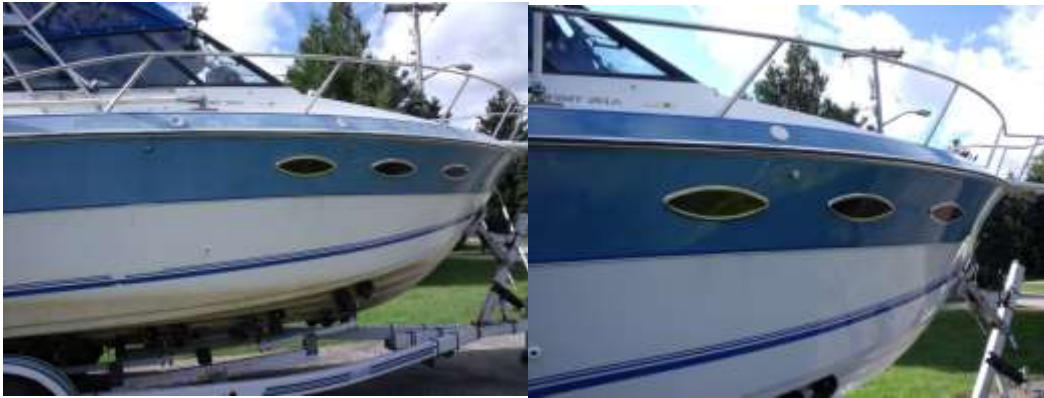
The boat was then allowed to completely dry. Areas such as the gas port, fresh water port, and waste water port were all masked off. Vents for onboard tanks were also masked off to prevent spray entering system.

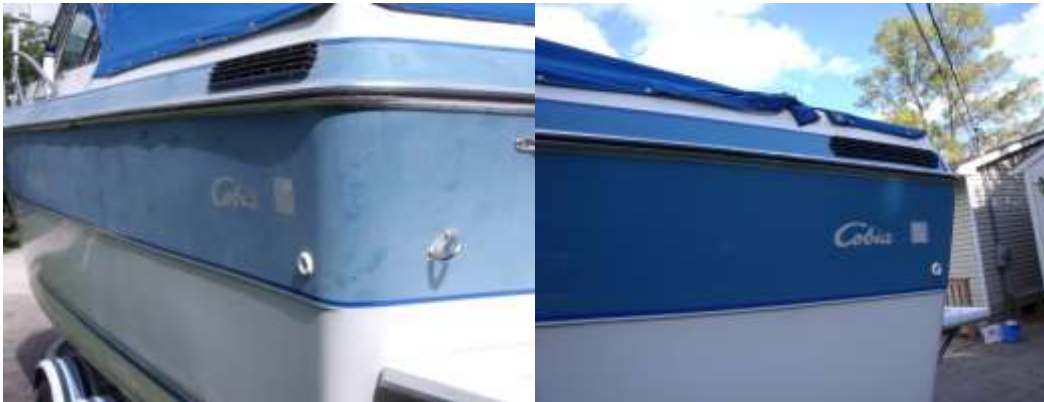
A high volume/low pressure (HVLP) spray gun was used to apply the material on the lower hull while a sponge was used on the upper section of the hull. A coating of 1-2mil was applied and allowed to dry. The coating was dry to the touch in approximately 2 hours. Drying time depends on the temperature and humidity.

**SOLUTION:** The C2T application was much less expensive than other maintenance solutions in the life cycle of the boat. One C2T coating will last 10 years while normal waxing lasts 1-2 years. The coating provides 50% less drag in the water resulting in reduced fuel costs. These enhancements will add to the resale value of the boat while extending its useful service life.
