## Corrosion Prevention Material Case History

### Corrosion Repair and Protection:

### Ford F-350 Pickup Truck

**DATE:** September 2013

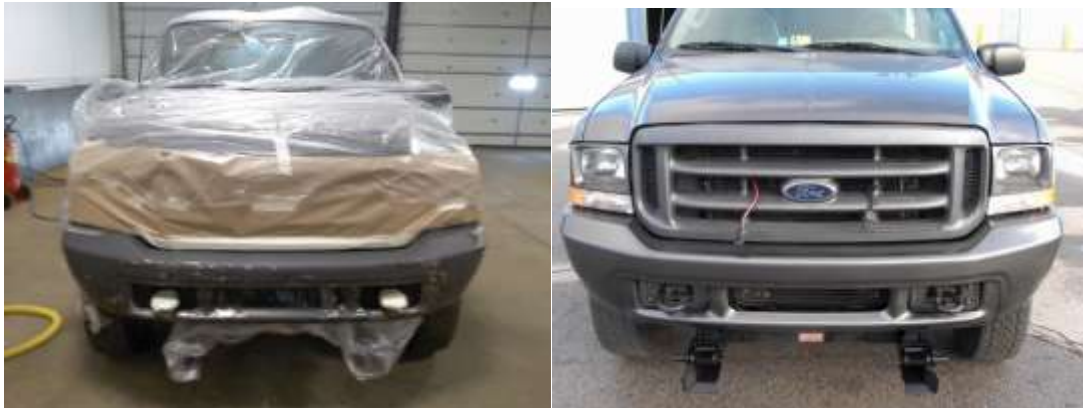
**PROBLEM:** The 2008 Ford F-350 truck was showing signs of wear and corrosion. Outside parking areas for the truck created badly faded/oxidized paint due to UV light exposure. The use of deicing compounds and salt used on roadways and parking lots created corrosion on door seams and underbody suspension areas.

**APPLICATION:** Using HEPA filtration vacuum-assisted surface preparation tools, the severely oxidized paint areas on the front bumper were sanded, primed, and painted using OEM compatible coatings.
