Corrosion Prevention Material Case History

Corrosion Repair and Protection: Steel Silos

DATE: July 2006

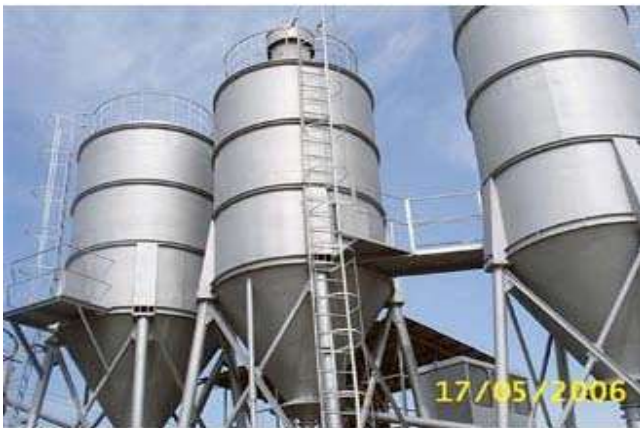
SOLUTION: The environmentally friendly primer and topcoat offered restoration of the silos to a clean looking and attractive appearance. The application of these coatings was selected to reduce environmental impact and to avoid sandblasting operation. The

owner now enjoys the benefit of a restoration project that will provide protection in harsh, outdoor environments for years to come.
